Scotts Creek
Watershed Action Plan

Jackson County
November 2018

Stormwater Management *Site Identification & Conceptual Designs*

SCOTTS CREEK POTENTIAL STORMWATER SCM LOCATIONS

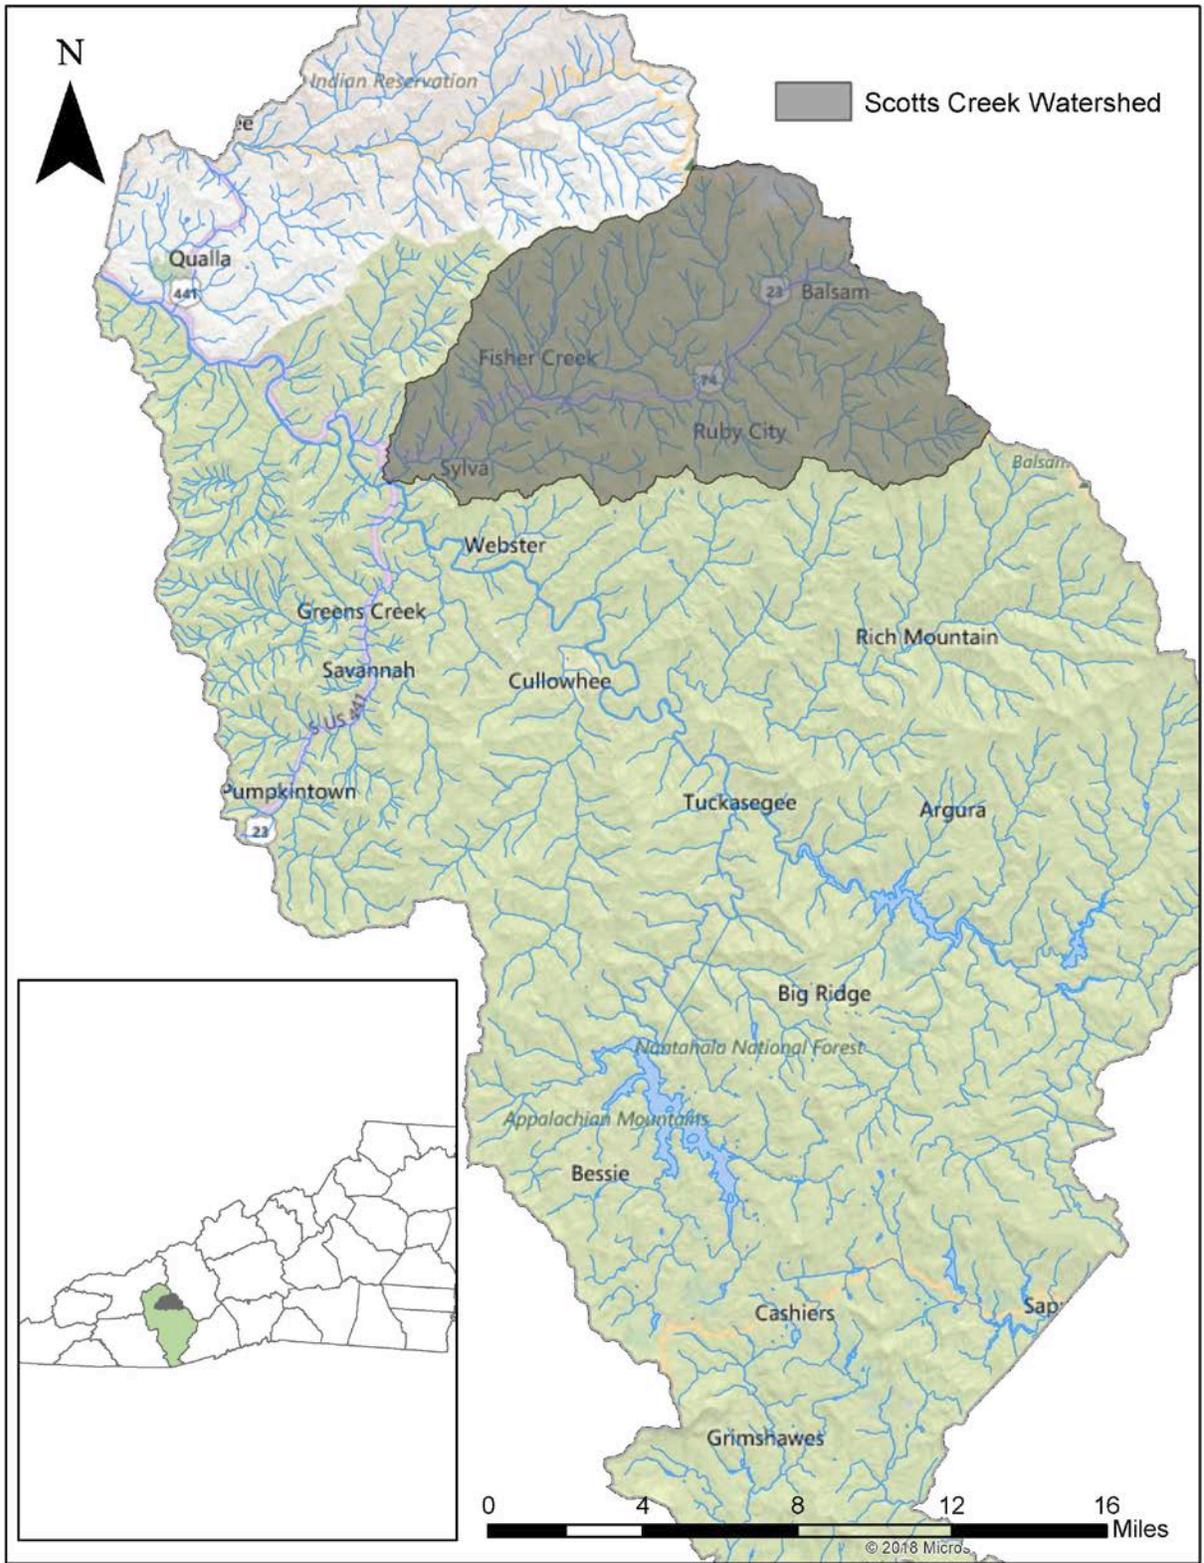
Figure 1. Location of Scotts Creek Watershed in Jackson County, NC.

The Scotts Creek Watershed considered for this plan consists of the entirety of the Headwaters Scott Creek subwatershed (Hydrologic Unit Code (HUC12) = 061002030302) and a small portion of the Scott Creek -Tuckasegee River subwatershed (HUC12 = 060102030303) which is the drainage area of Cope Creek (Figure 1). The Cope Creek drainage was considered because it is a first order tributary of Scotts Creek and is partially within Town of Sylva municipal limits. Primary tributaries to Scotts Creek include Dark Ridge Creek, Sugarloaf Creek, Ochre Hill Creek, North Fork Scott Creek, Buff Creek, Blanton Branch, Fisher Creek, Monteith Branch, Kitchen Branch, Allens Branch, Cope Creek, and Dills Branch. Scotts Creek originates near the Blue Ridge Parkway, the Balsam community, and the Haywood and Jackson county line, then runs parallel to US 23/74 and Old US 19/23 for most of its 15.3- mile length. The stream passes through many residential areas before entering the urban environment in Sylva and Dillsboro.

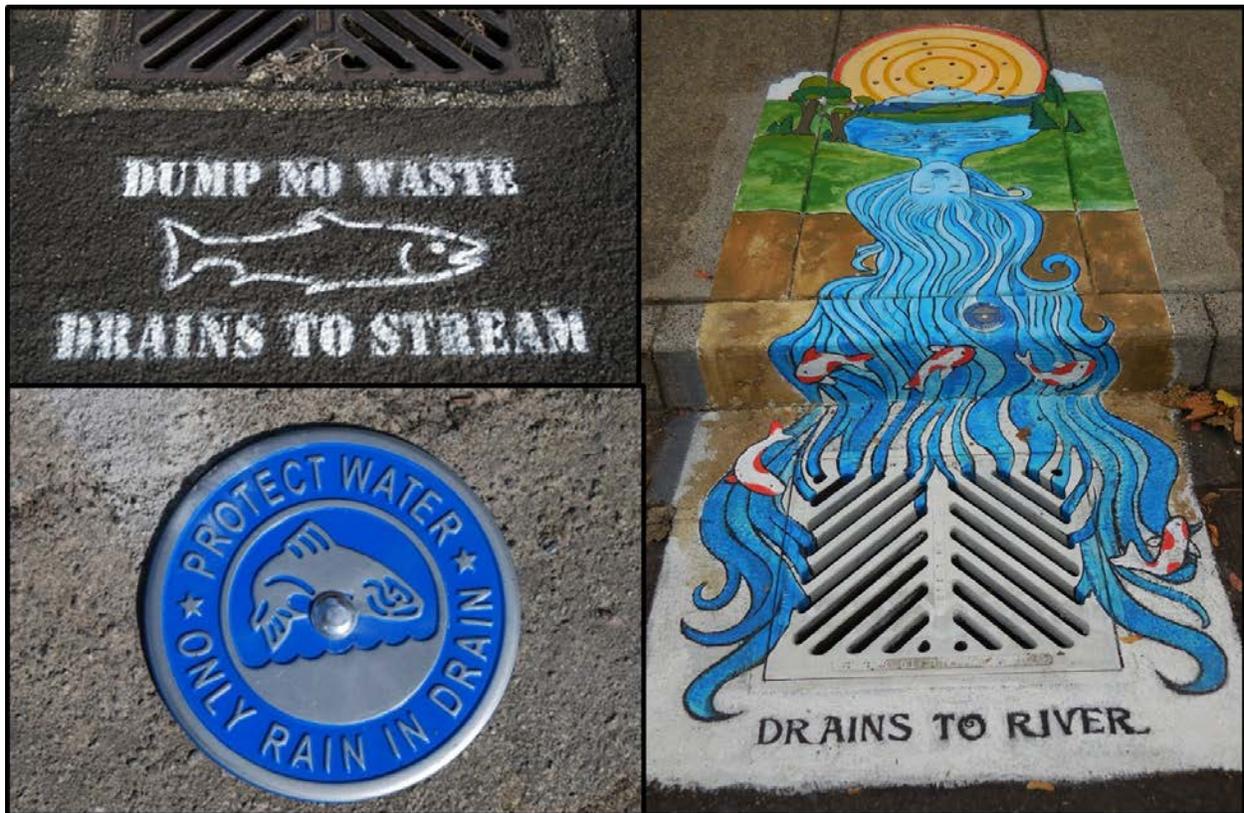
Figure 10. Examples of storm drain marking in the Chesapeake Bay (left) and Vancouver, BC (right).

Storm drain stenciling and marking is a cost effective and easy way to convey to educate the public that everything that goes down a storm drain flows, untreated, into a nearby stream. Stenciling can bring together community organizations and civic groups to give them a vested interest in improving water quality. Storm drain murals are also becoming increasingly popular. These can be quite visually striking and educational (Figure 10).

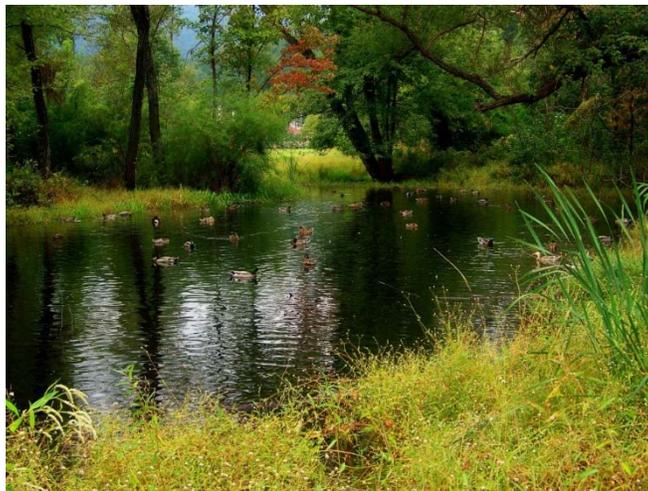
Figure 5: Early establishment of a Riparian Buffer

Riparian buffers are vegetated areas directly adjacent to streams and rivers (Figure 5). The re-establishment of buffers is becoming more common as a response to the negative effects of historic agricultural and industrial land uses developing right to the water's edge. A vegetated buffer helps intercept sediment, nutrient, and pollutant runoff from adjacent land uses. Riparian buffers, often forested, help shade and cool the water in the stream or river, improving water quality and creating micro-climates. The vegetation acts to stabilize the banks of the waterbodies reducing erosion and further sedimentation downstream as well as acting as habitat.

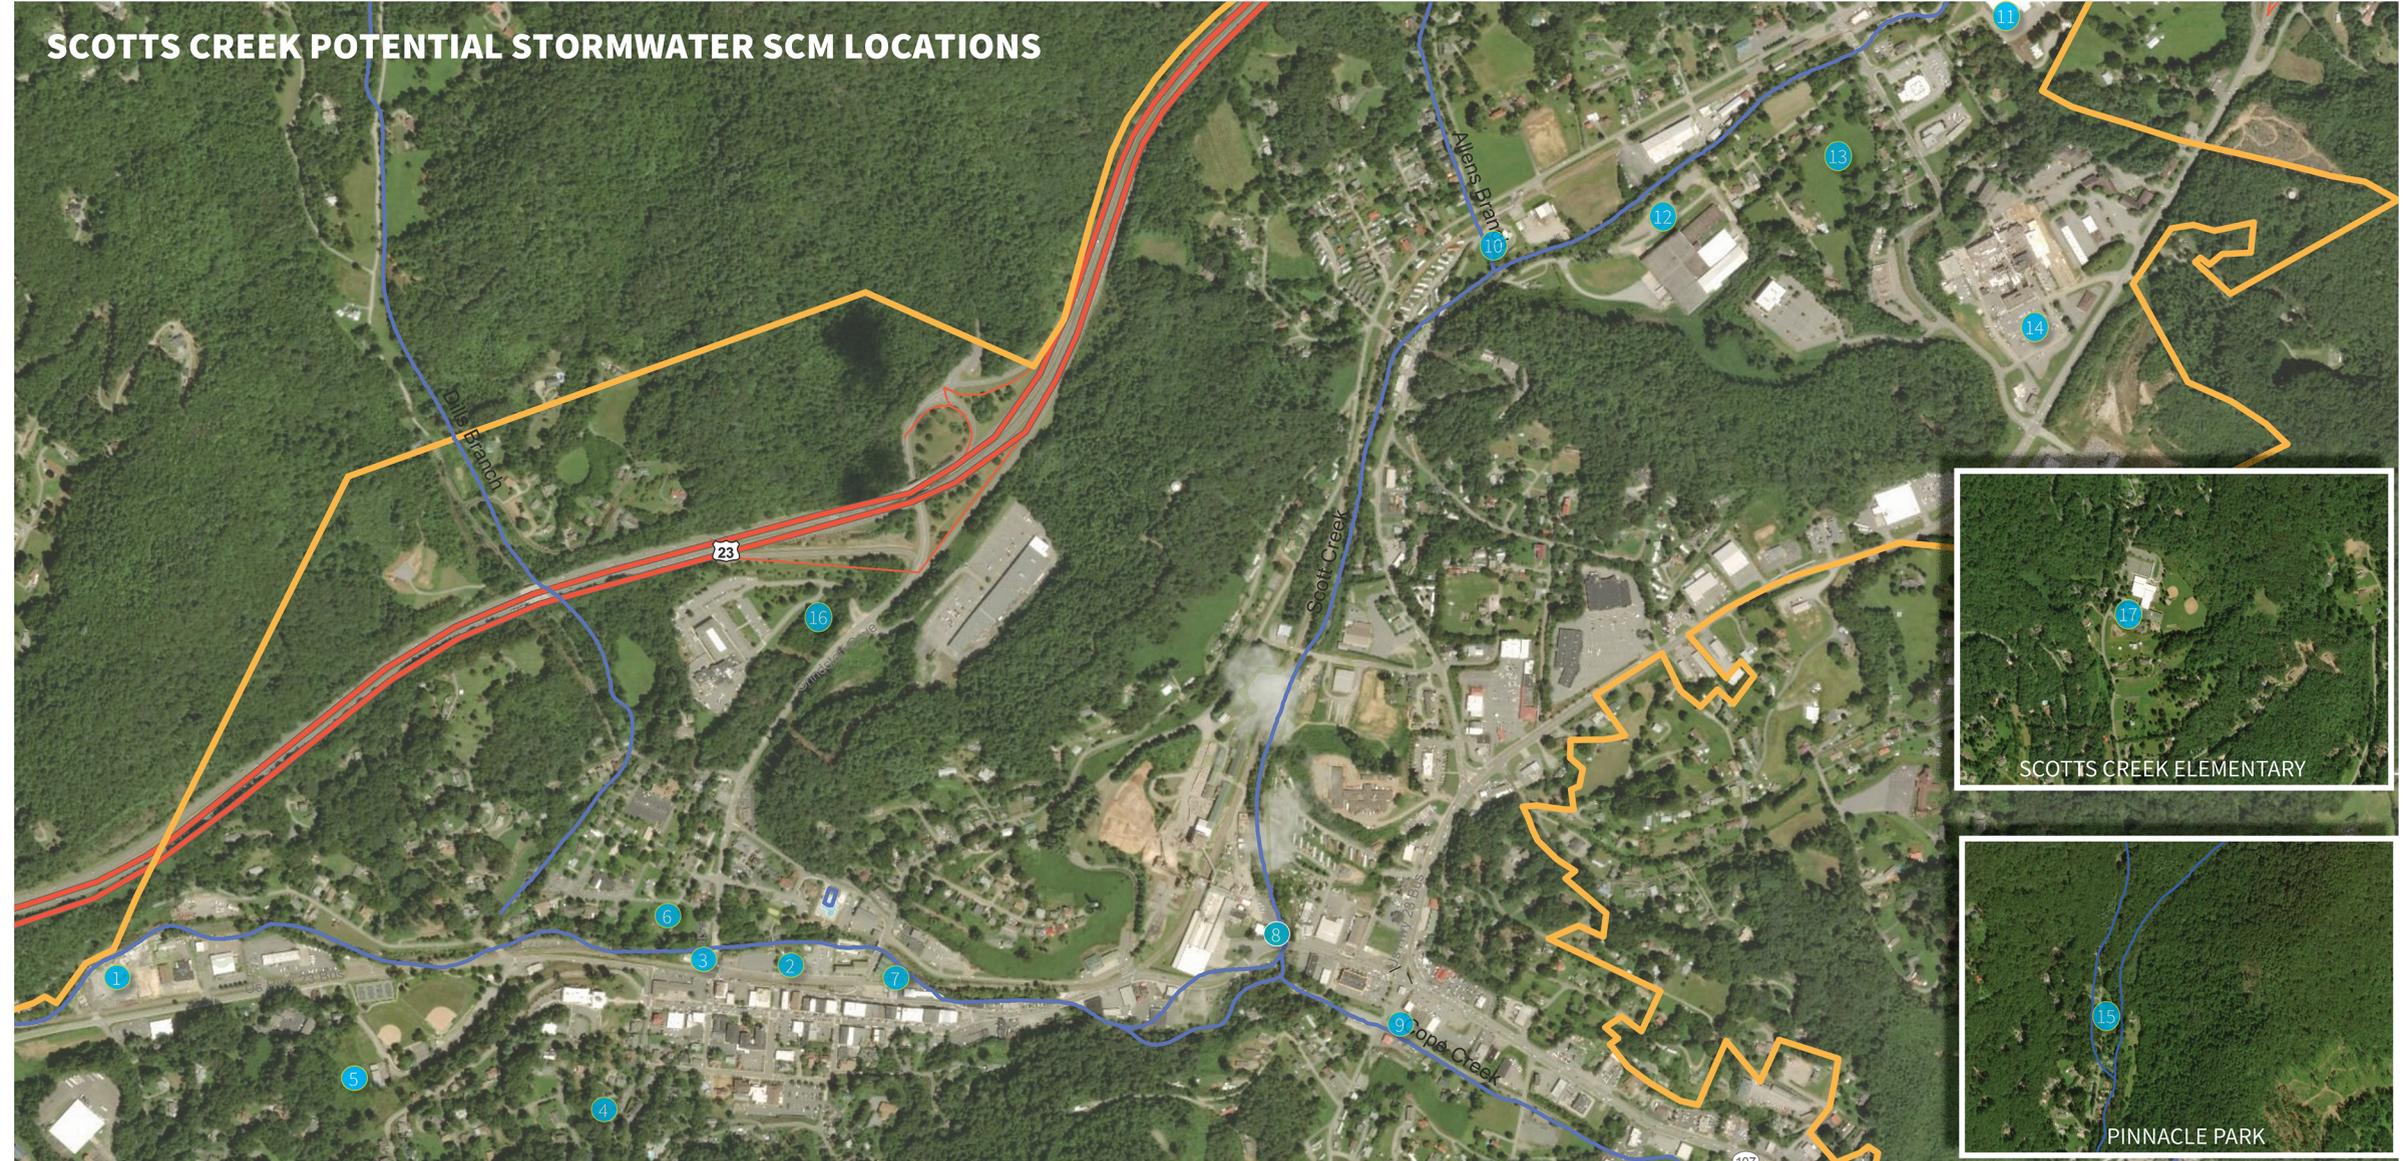
Site	Property Name	Type of SCM	Was The Site Observed?	Public Land	Land Use	Drainage Area* (acres)	Impervious Area (acres)	Percent Impervious (%)	Surface Area REQUIRED for SCM(s) (square feet)	Surface Area IDENTIFIED for SCM(s) (square feet)
1	Southern Concrete Materials	Riparian Buffer	Yes	No	Industrial	N/A	N/A	N/A	N/A	N/A
2	Bridge Park	Bioswale, Bioretention, Riparian Buffer, In-stream Structures	Yes	Yes	Public	6.5	5	85	32,000	4,000
3	Nantahala Brewery	Raingarden, Riparian Buffer	Yes	No	Commercial	0.12	0.12	100	540	540
4	Bicentennial Park	Bioswale, Bioretention	Yes	Yes	Public	0.85	0.37	43	3700	2500
5	Mark Watson Park	Wetland Enhancement	Yes	Yes	Public	N/A	N/A	N/A	N/A	N/A
6	Community Garden	Raingarden	Yes	No	Institutional	0.4	0.14	35	1700	1200
7	Motion Makers Bike Shop	Bioretention, Riparian Buffer	Yes	No	Commercial	1.5	0.83	55	6700	3000
8	Jackson Paper	Riparian Buffer	Yes	No	Industrial	N/A	N/A	N/A	N/A	N/A

9	Kel-Save	Riparian Buffer	Yes	No	Commercial	N/A	N/A	N/A	N/A	N/A
10	Herron Branch Road	Riparian Buffer	Yes	No	Residential	N/A	N/A	N/A	N/A	N/A
11	Parking Lot	Raingarden	Yes	No	Commercial	5.6	4.9	90	24,300	1,600
12	Agricultural Field	Riparian Buffer	Yes	No	Farmland	N/A	N/A	N/A	N/A	N/A
13	Jackson County Services Building	Raingarden, Bioretention	Yes	Yes	Government	1.29	1.17	91	5600	3100
14	Hospital Parking	Bioretention	Yes	No	Institutional	0.69	0.69	100	3000	1200
15	Pinnacle Park	Bioswale, Bioretention	Yes	Yes	Public	2.5	0	0	10,840	1000
16	Jackson County Justice Center	Bioretention	Yes	Yes	Government	1.1	1	90	4700	4700
17	Scotts Creek Elementary School	Bioswale, Cisterns	Yes	Yes	Public	0.14	0.14	100	N/A	N/A

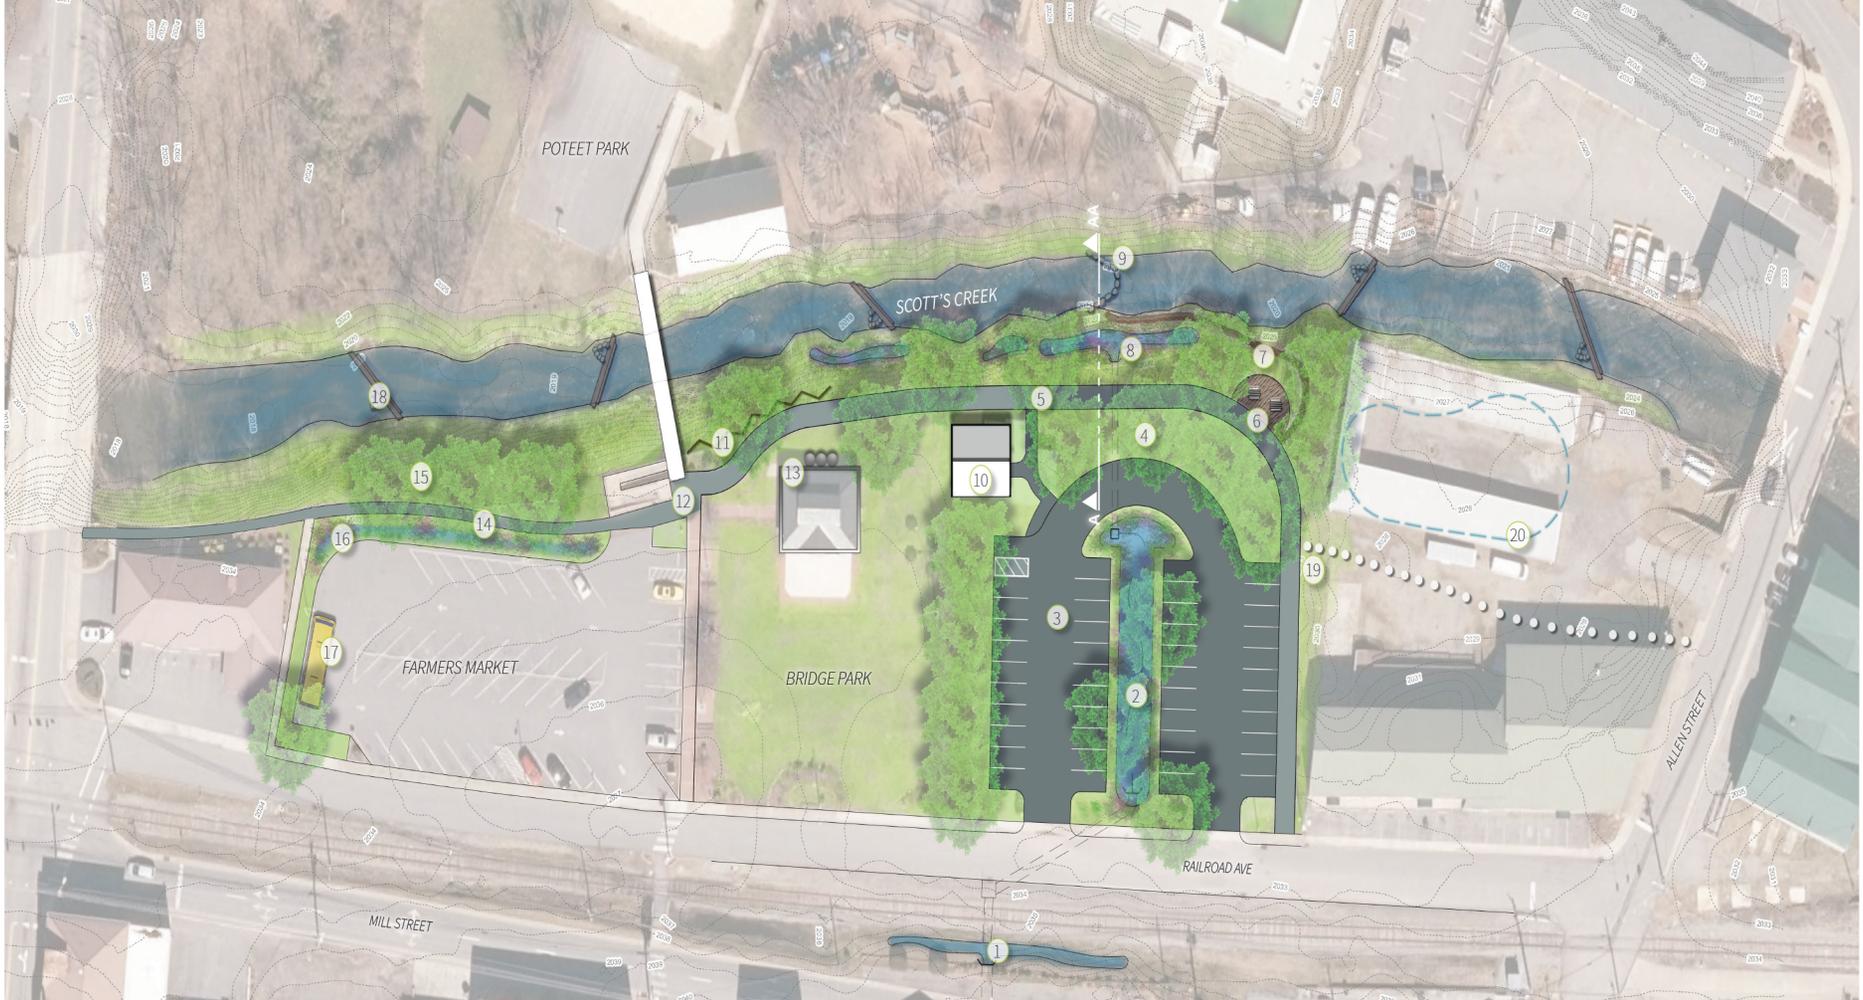
Bridge Park Concept

| | 13 RETROFIT EXISTING STAGE WITH RAINWATER COLLECTION SYSTEM (CISTERNS OR RAIN BARRELS) | 20 OPTIONAL STORMWATER TREATMENT- IF STORAGE BUILDING IS DEMOLISHED, UTILIZE AREA FOR FLOODPLAIN STORAGE VIA STORMWATER POND (DASHED BOUNDARY) |

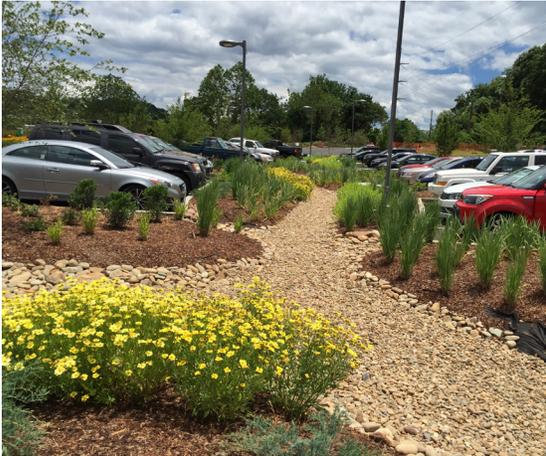
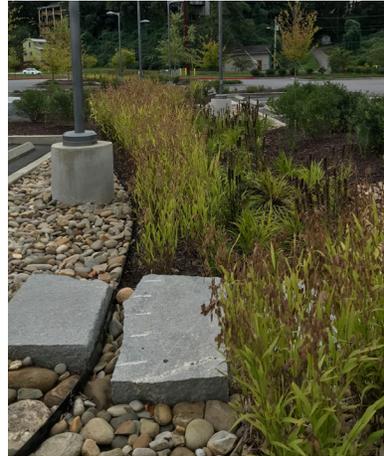
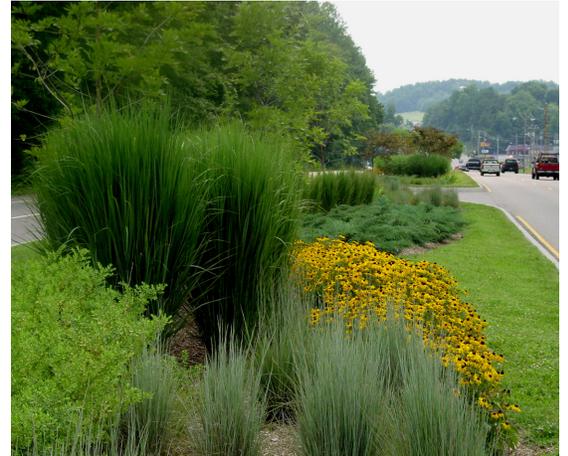
BIORETENTION

Bioretention features are depressions that rely on soils and plants to treat storm runoff, using many of the water storage and pollutant-removal mechanisms that operate in healthy forests. During storms, water temporarily ponds on the surface of a sand/soil bed and then infiltrates slowly through the bed. Nutrients are taken up by plants while microbes break down organic substances (Figure 1). Bioretention cells are intended to "draw down" or empty within 24-48 hours following a rain event, alleviating stagnant water and mosquito breeding concerns. Cells can be designed to infiltrate water directly into native soils, if these soils are sufficiently permeable. If not, special soil media and underdrain systems may be necessary or a system of sand layers to encourage infiltration. To reduce the sizing requirements of bioretention features, a structure can be installed to limit the amount of water the bioretention receives to the first inch of rain. Larger storm volumes bypass the bioretention cells protecting them from receiving amounts of water beyond what they are capable of treating. Overflow structures are typically installed within the bioretention cell, especially when a bypass structure, such as a curb cut in a parking lot, is not feasible. Bioretention can be used in a variety of topographic conditions, and can generally treat runoff from areas of one acre or less.

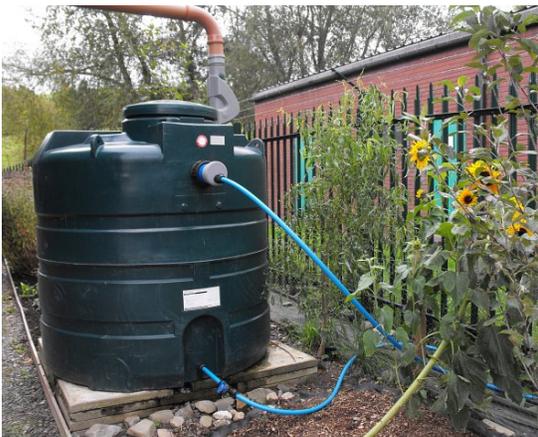
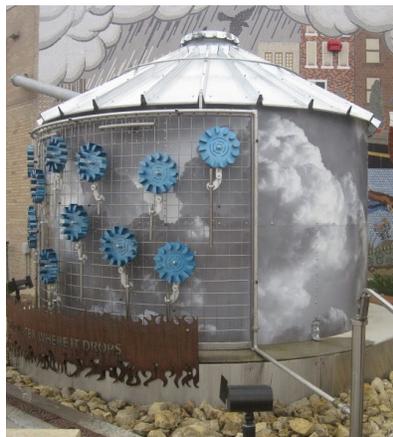
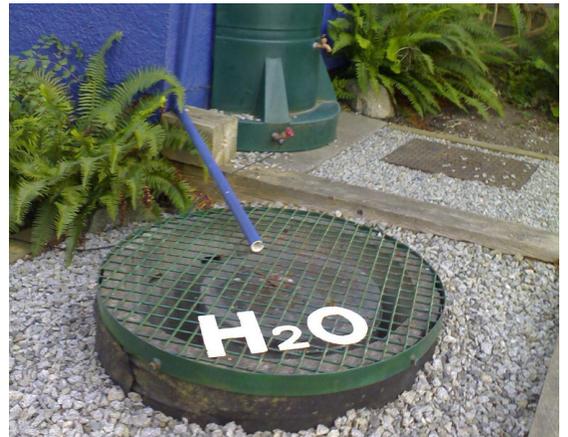
RAINWATER COLLECTION

Rain barrels and cisterns provide a storage device to capture rooftop drainage for later use on the site. Many people capture and reuse this water for their gardens and landscape plantings. Rain barrels come in a variety of sizes, shapes, and colors. It has become fairly commonplace to find 50 to 75-gallon barrels that make attractive additions to the landscape (Figure 6), while cisterns tend to be much larger and may even be designed to be used for non-potable indoor plumbing. A simple, 50-gallon plastic rain barrel will typically cost \$100 or less. Users of this practice will need to make sure that they have screens over openings to keep mosquitoes from using the reservoir as a breeding ground. They will also need to direct overflow to a suitable location to keep it from seeping into foundations and basements. Cisterns can be located below ground (Figure 7) to store water in tight spots or above ground (Figure 8) and used for educational purposes.
